Active Shoreline Changes of Büyük Menderes River Delta in Last 50 Years

M. Lütfi Süzen⁽¹⁾ & Bora ROJAY⁽²⁾

Geological Eng.Dept., Middle East Technical Univ., 06531 Ankara

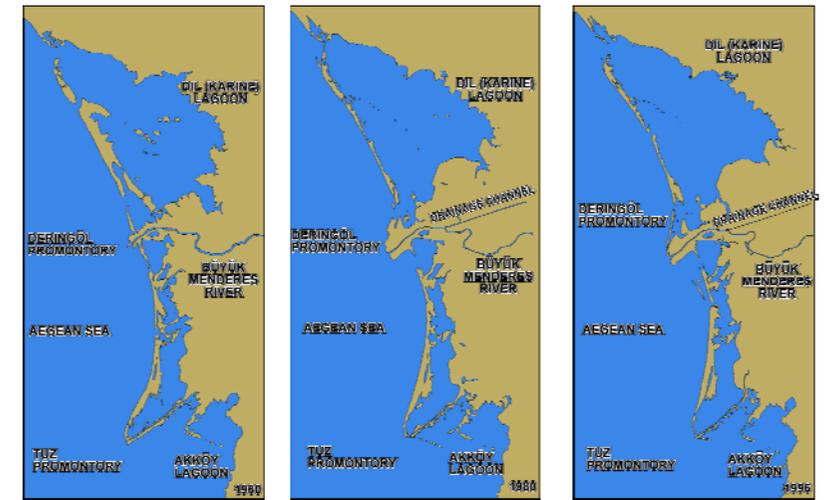
Fig 2. Multitemporal shorelines of 1957 (1960 map date), 1977 (1980 map date) and 1993 (1996 map date).

The stereoscopic aerial photographs have been interpreted and geomorphological features are mapped. The maps of different periods are scanned then registered to real earth coordinates with national datum information. Following this in all of the periods the position of the shoreline is digitized and then stored. The point information provided by the field observation stations are also used to create a continuous shoreline of 2004. All of the produced shorelines are then overlaid to observe the changes (Fig 3).

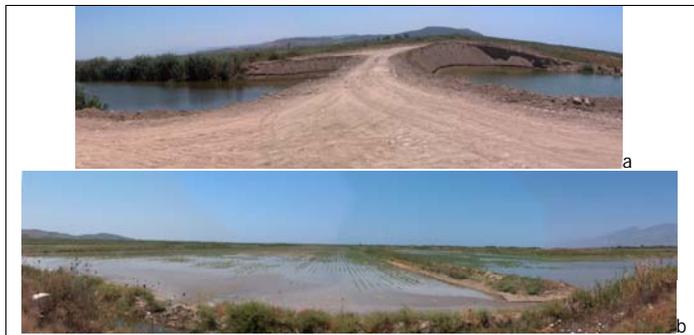
Fig 6. a) Small scale freshwater Dam on Büyük Menderes River, b) cotton field irrigation.

On the other hand in the northern promontory where the water is diverted by channels an aggrading pattern and trend is observed (Fig. 5). However in summer times the channel is blocked by small scale dams (Fig. 6) to store fresh water for irrigation of cotton which completely cuts down the discharge of Büyük Menderes River to Aegean Sea.
